Conserving Calgary's Historic Streets

A conservation plan for 27 of Calgary's historic streetscapes

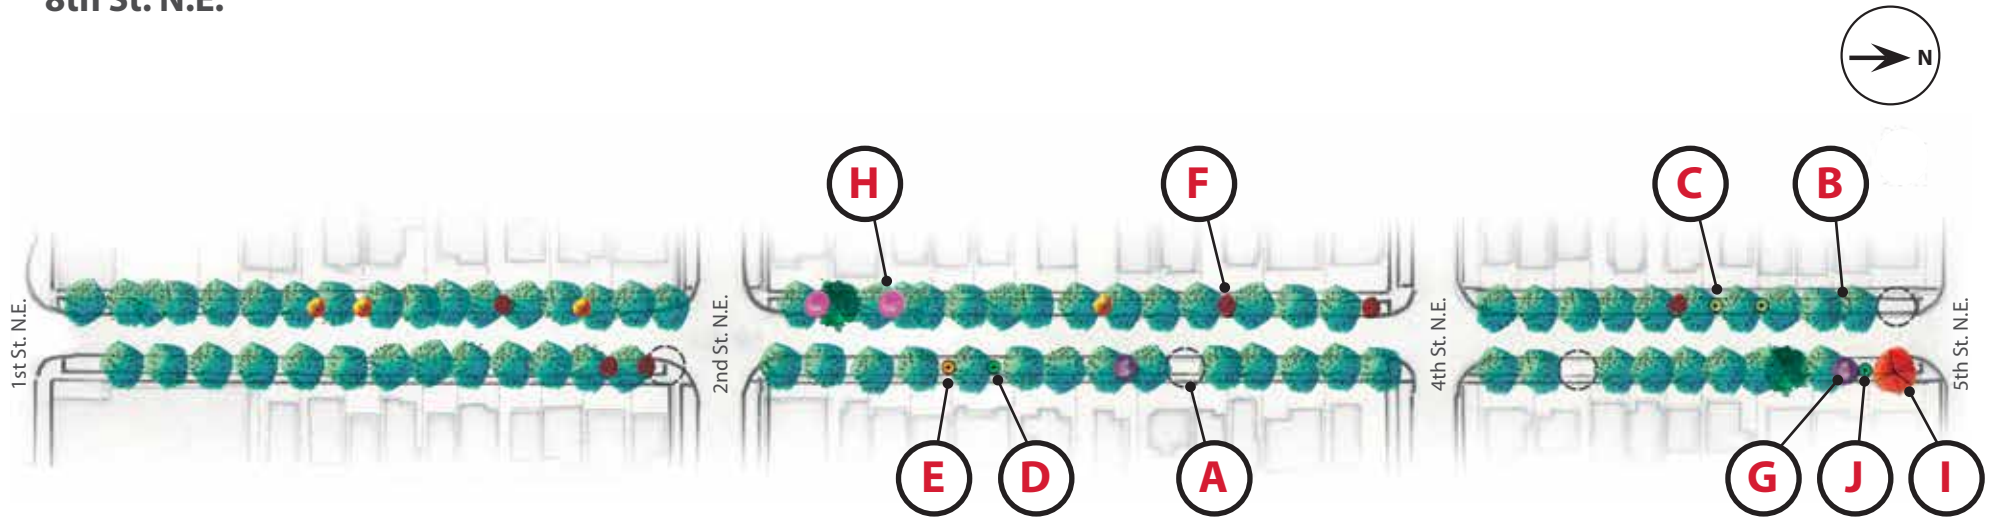
8th St. N.E.

- A 4 missing elms
- B 40 missing cotoneaster

- I 1 large maple and 2 large green ash and replace when it is deemed too unsafe or too unhealthy by Urban Forestry
- J 1 newly planted elm

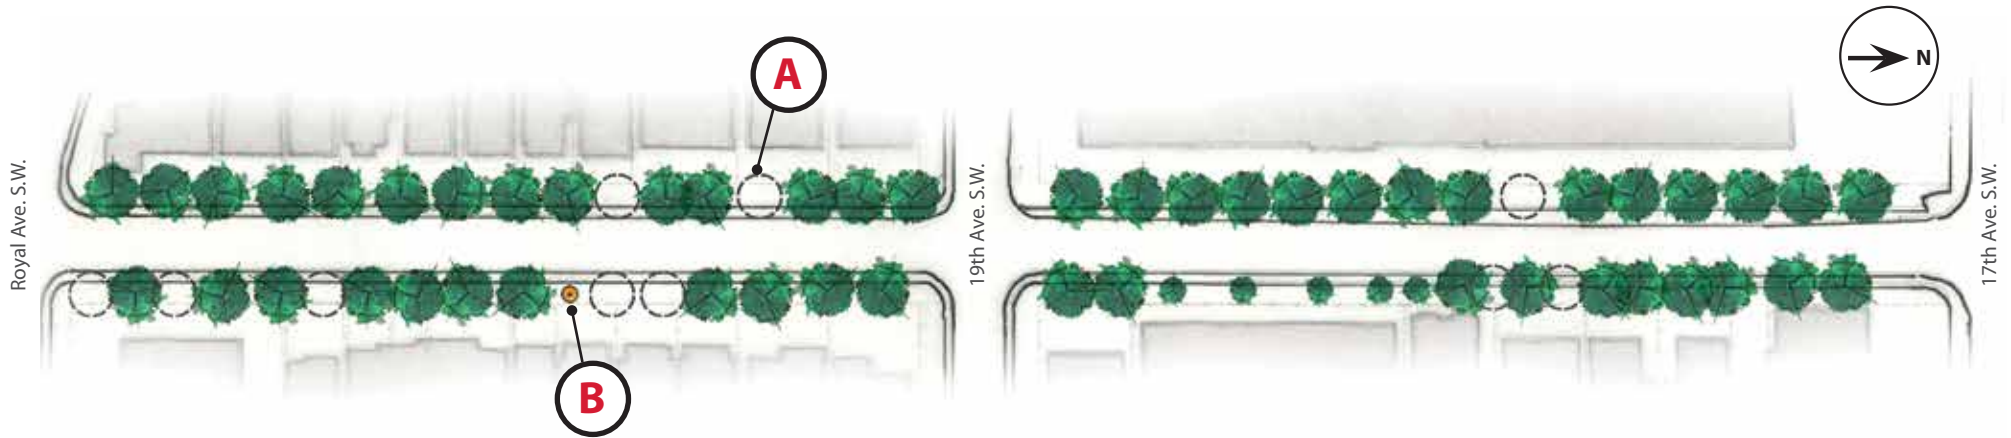
5A St. S.W.

A 10 missing green ash

B 1 newly planted oak with a green ash

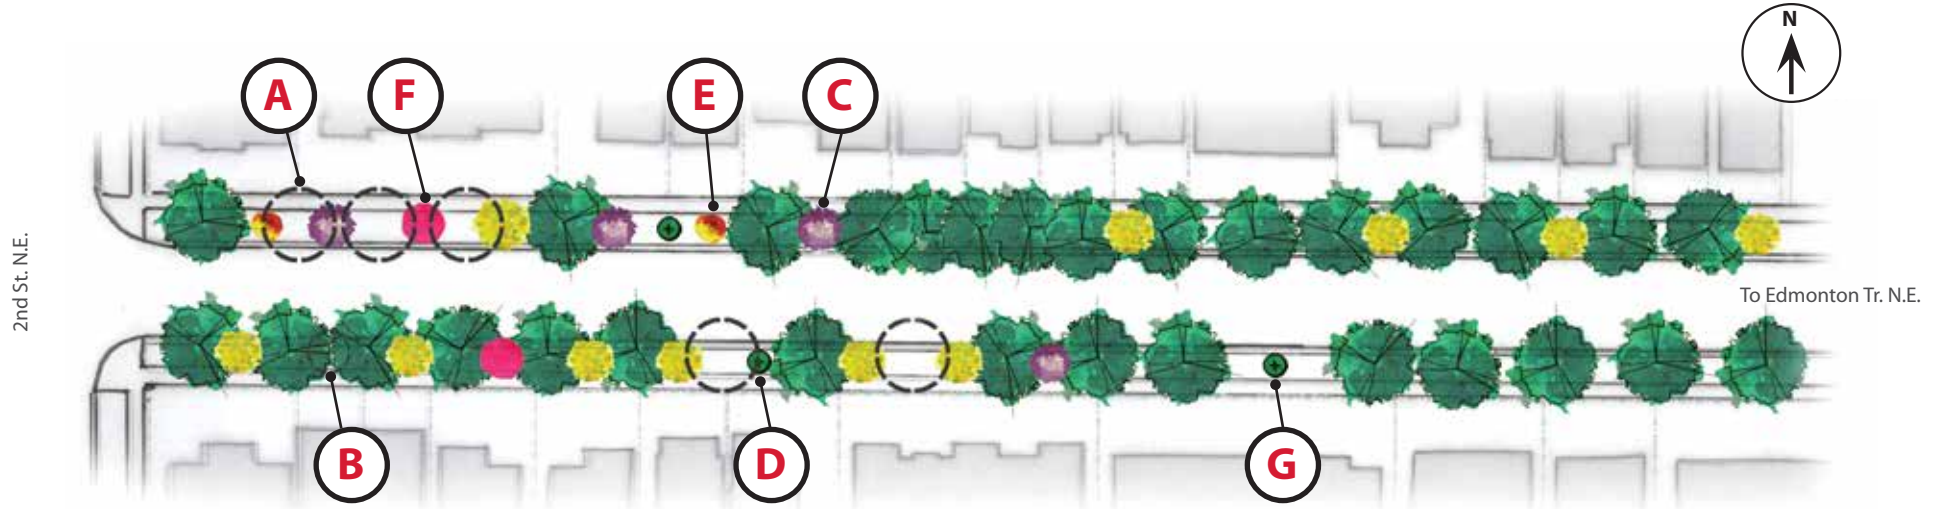
5th Ave. N.E.

- A 5 missing green ash
- B 12 missing caragana

- G 2 newly planted green ash

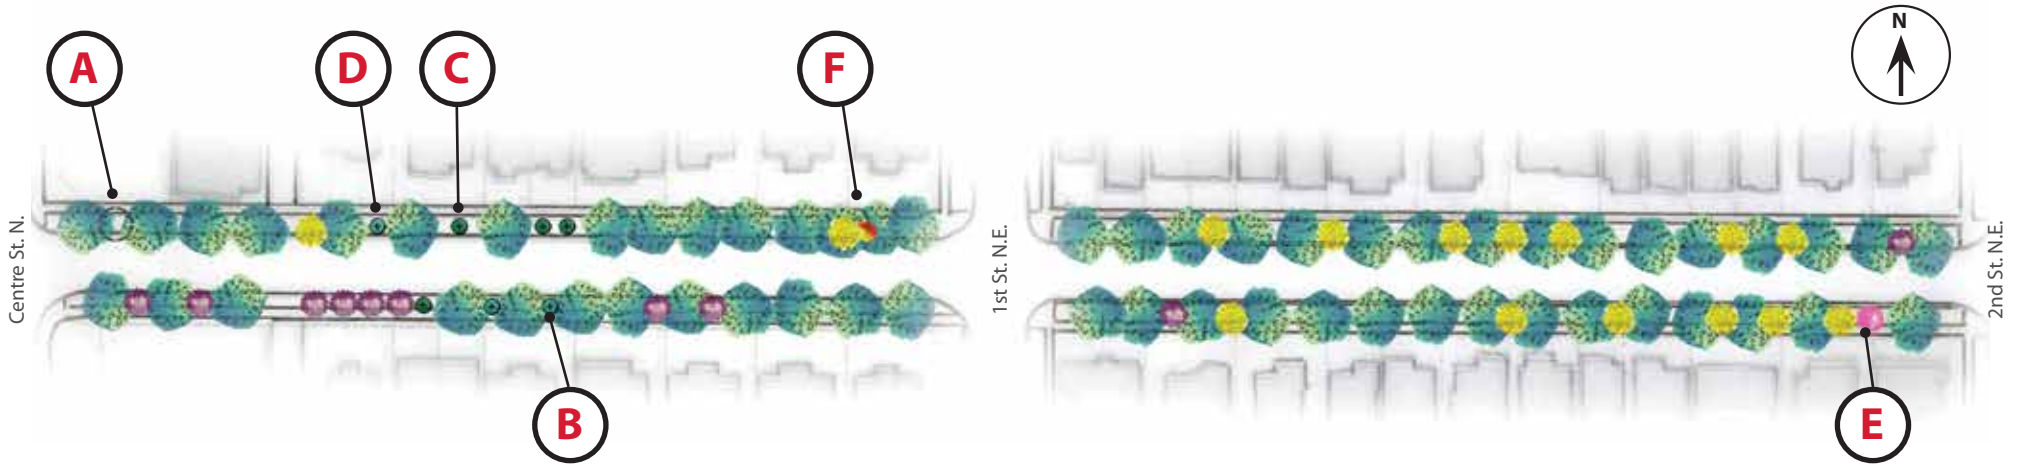
7th Ave. N.E.

A 34 missing caragana or lilac as required

F 1 cotoneaster

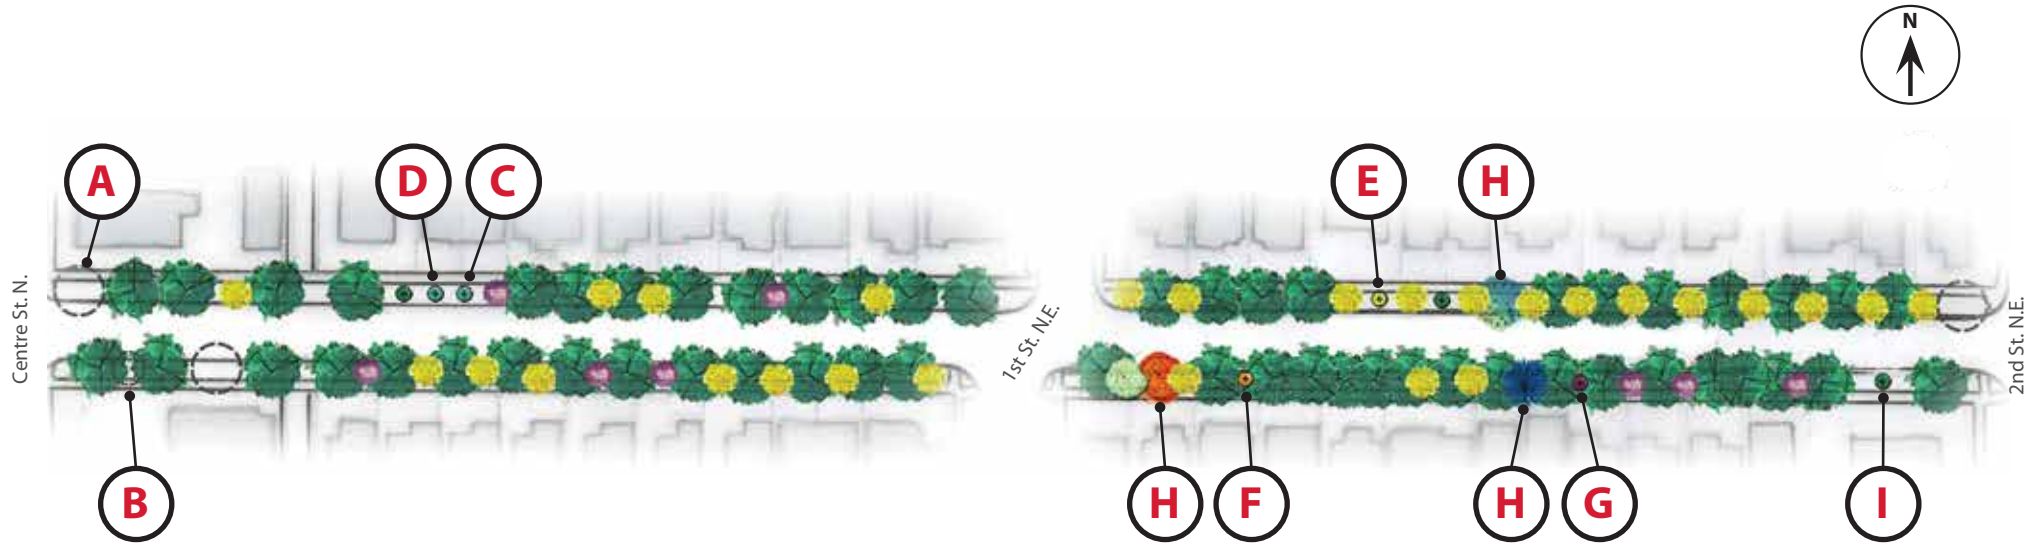
8th Ave. N.E.

- A 3 missing green ash
- B 17 missing caragana or lilac as required

- H 1 large elm, 1 large spruce, 1 mayday, and 1 horse chestnut. Replace when they are deemed too unsafe or too unhealthy by Urban Forestry
- I Newly planted green ash

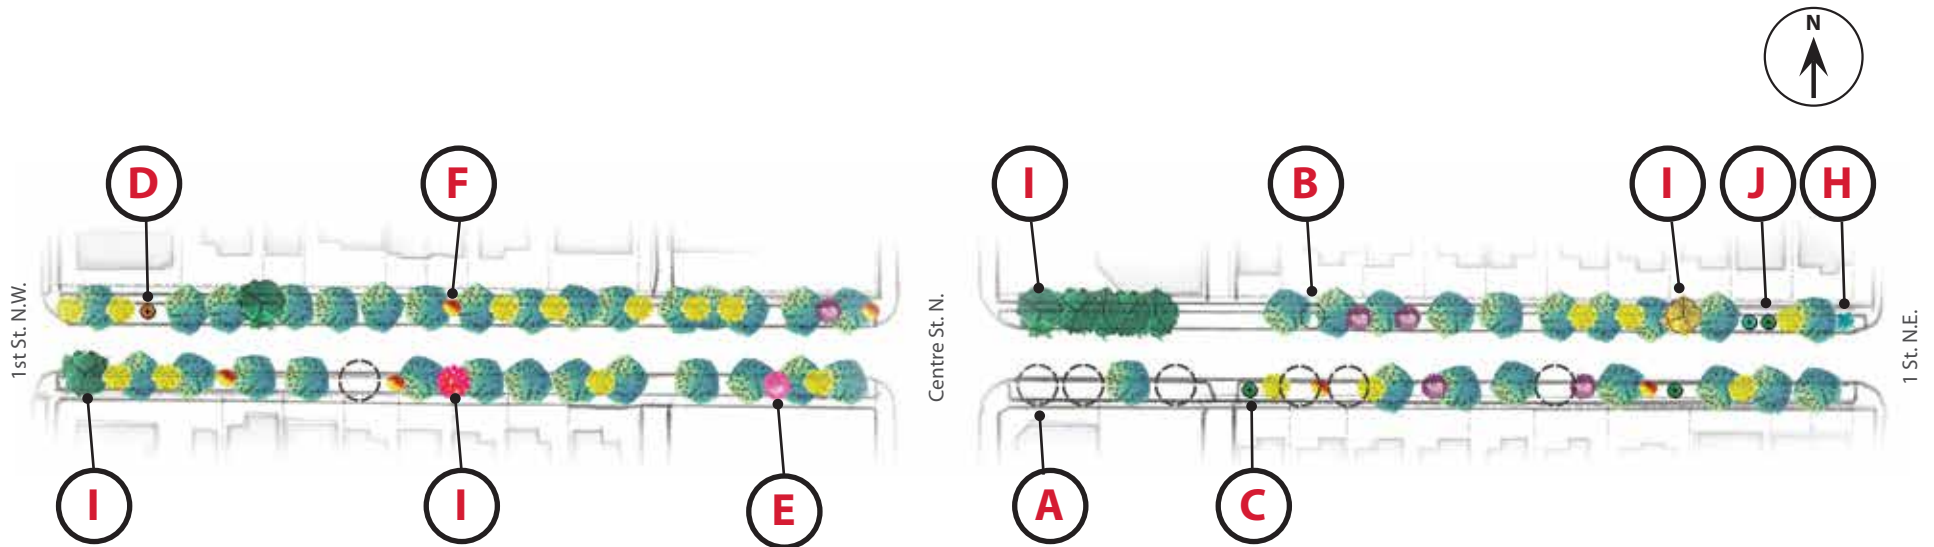
9th Ave. N.E.

- A 7 missing elms
- B 22 missing caragana or lilac as required

- I 5 large green ash, 1 crabapple and 1 mountain ash and replace when they are deemed too unsafe or too unhealthy by Urban Forestry
- J 1 newly planted elm

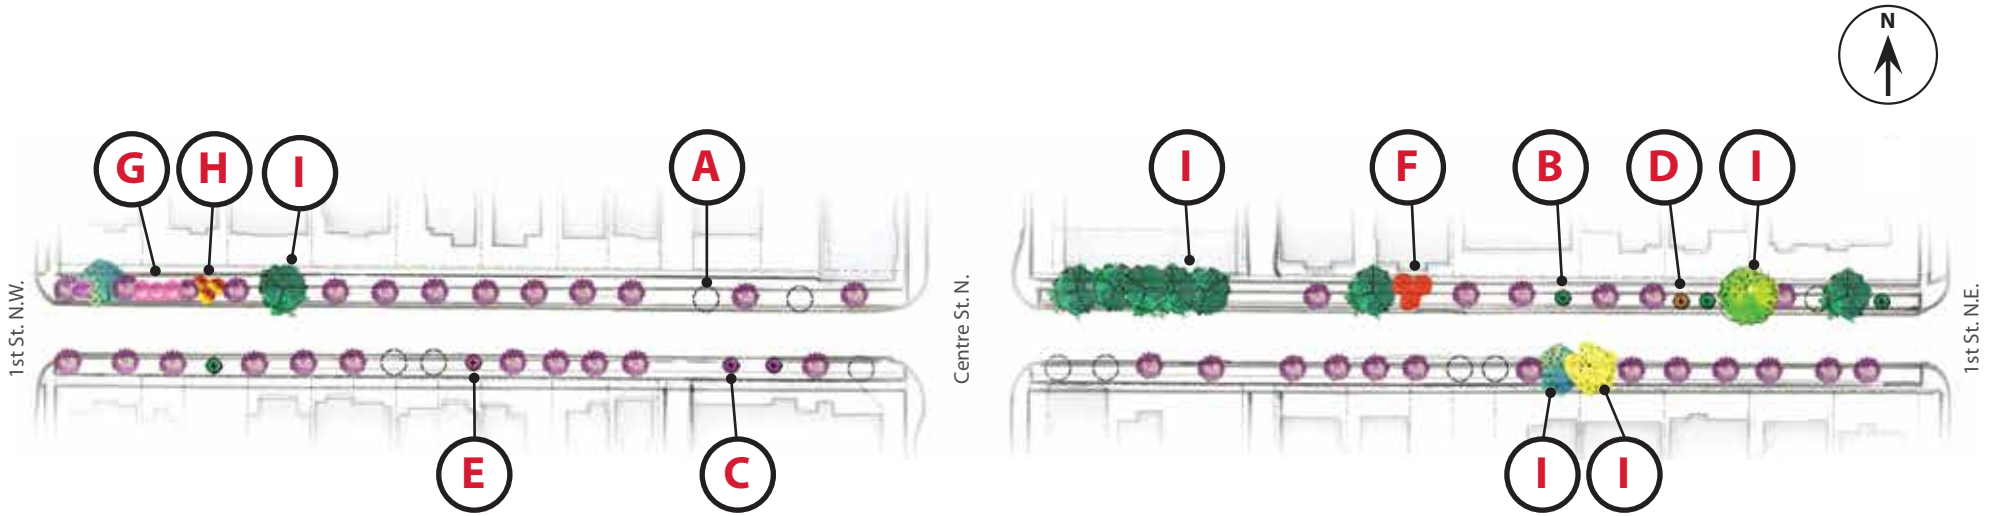
10th Ave. N.E.

A 10 missing lilacs

- I large poplar, 8 large green ash, 2 large elm, 1 large birch and replace when they are deemed too unsafe or too unhealthy by Urban Forestry

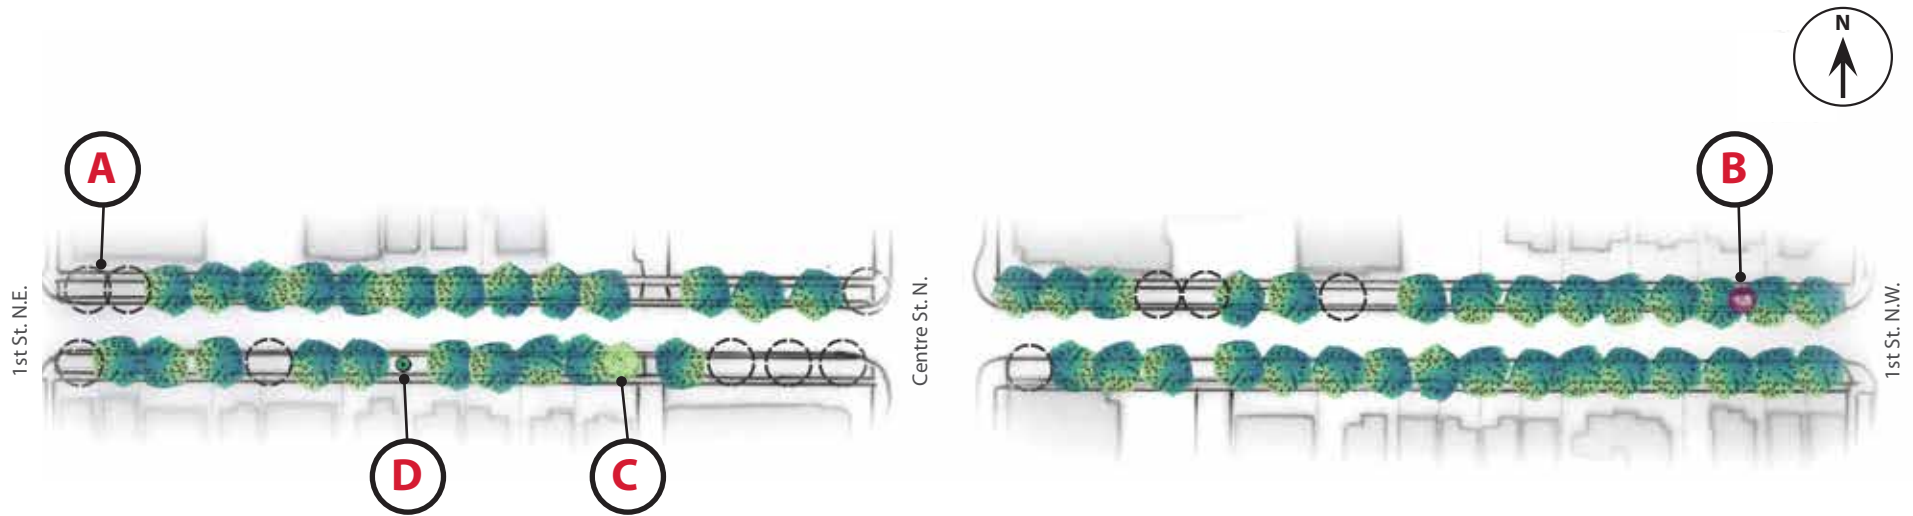
11th Ave. N.E.

A 12 missing elms

C 1 large mayday and replace when it is deemed too unsafe or too unhealthy by Urban Forestry

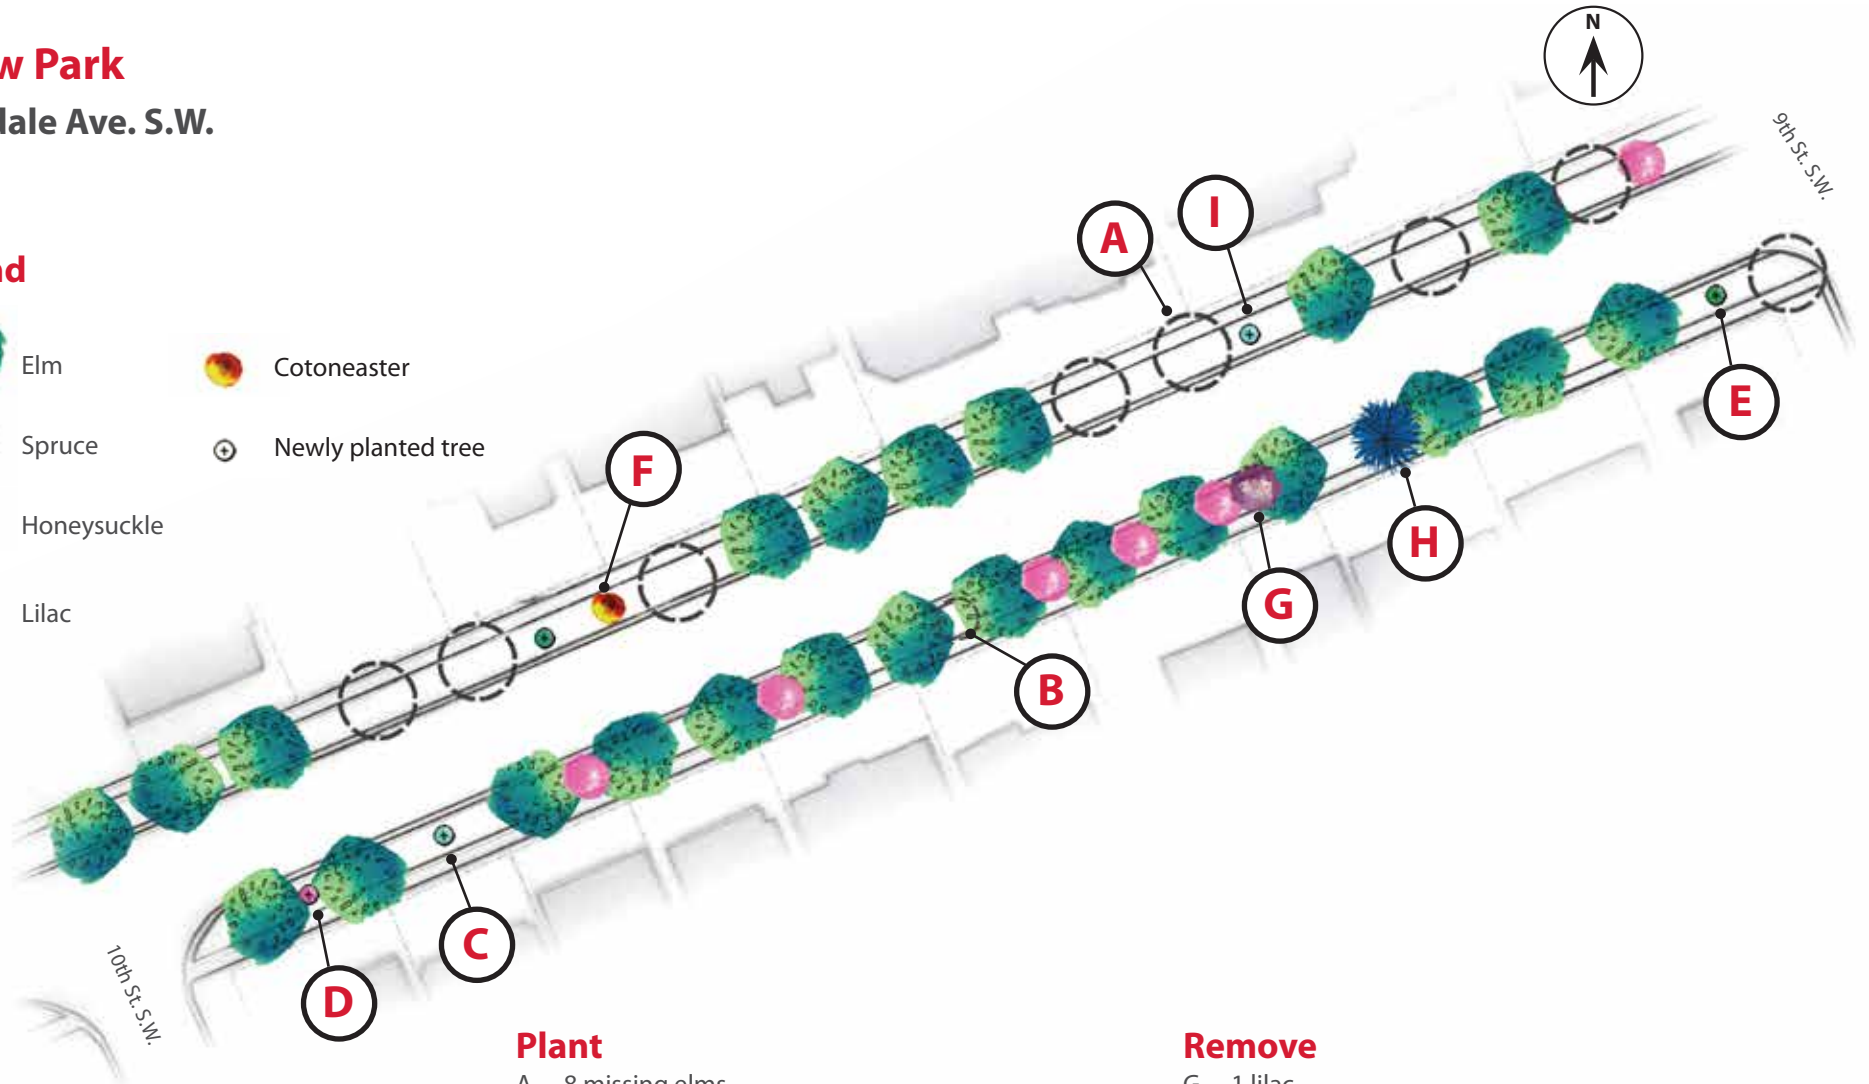
Riverdale Ave. S.W.

- A 8 missing elms
- B 20 missing honeysuckle

- H 1 large spruce and replace when it is deemed too unsafe or too unhealthy by Urban Forestry
- I 1 newly planted elm

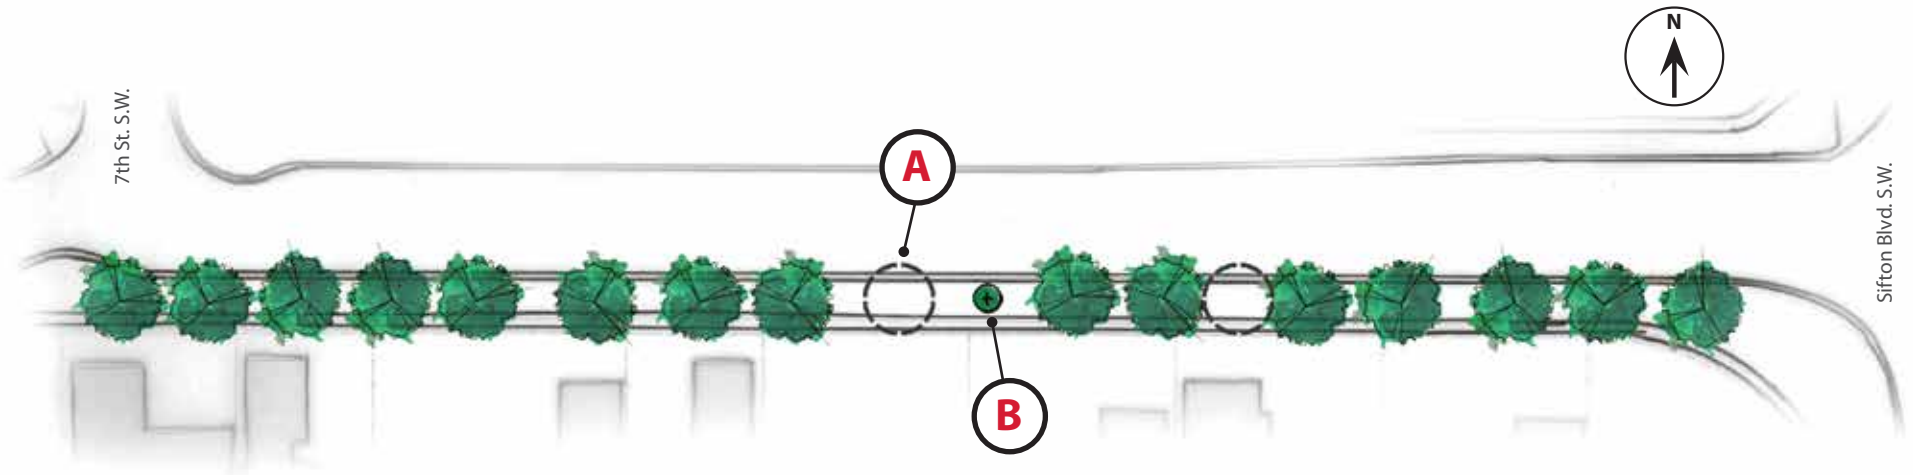
Sifton Blvd. S.W.

A 2 missing green ash

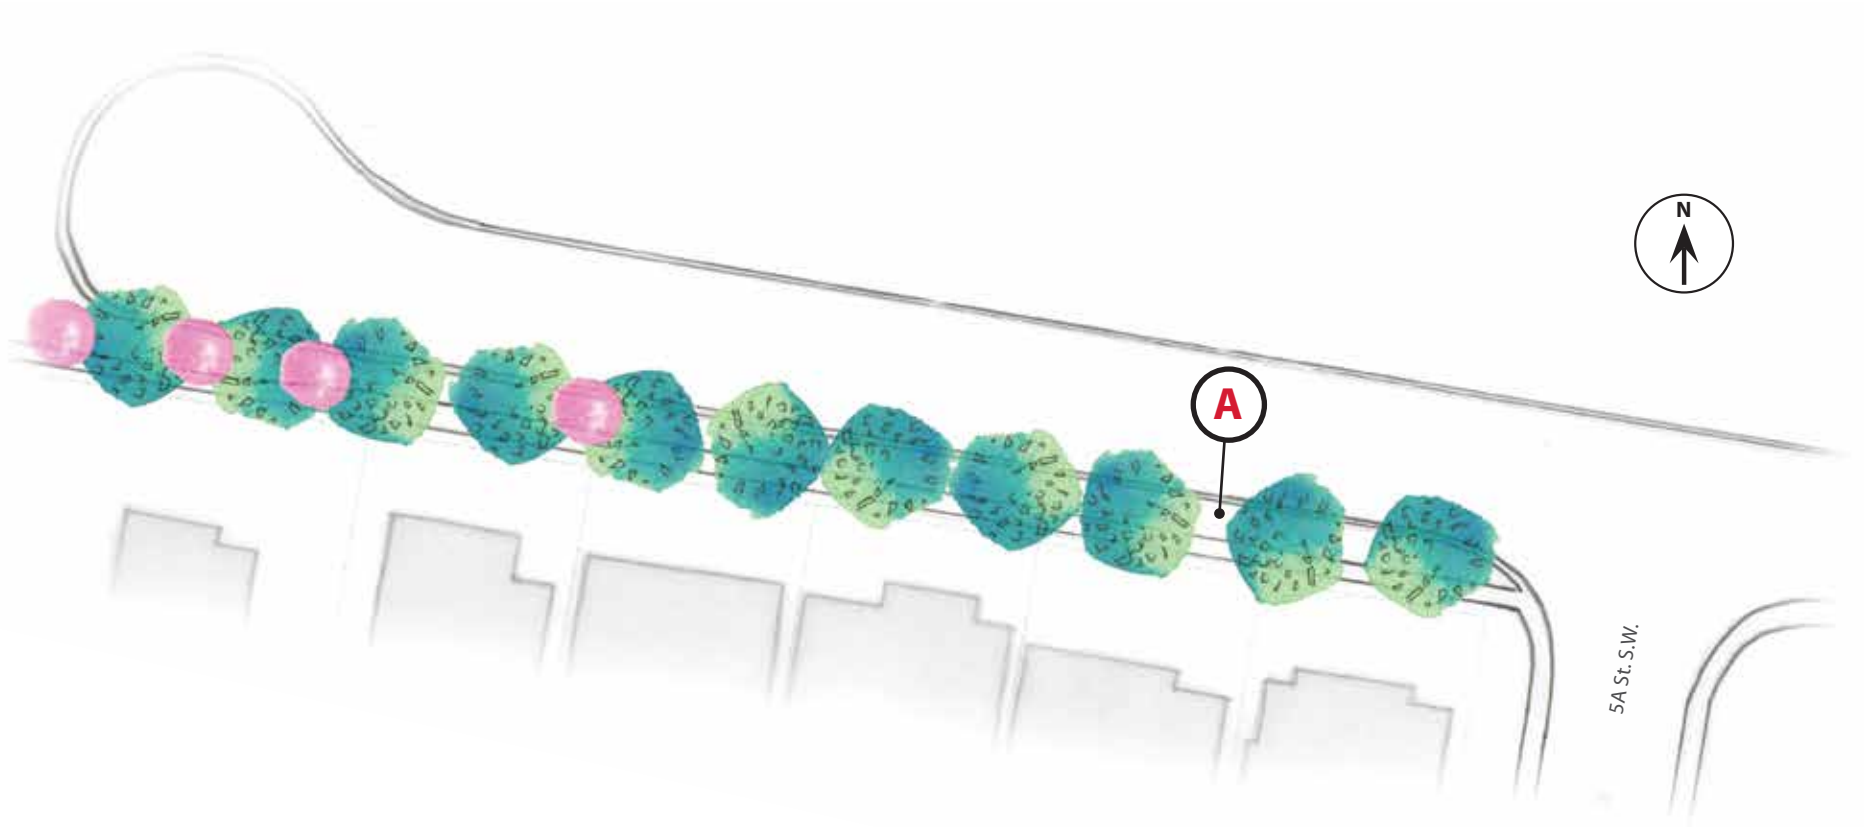
Riverdale Ave. S.W., from 5A St. to Elbow Dr. S.W.

A 7 missing honeysuckle

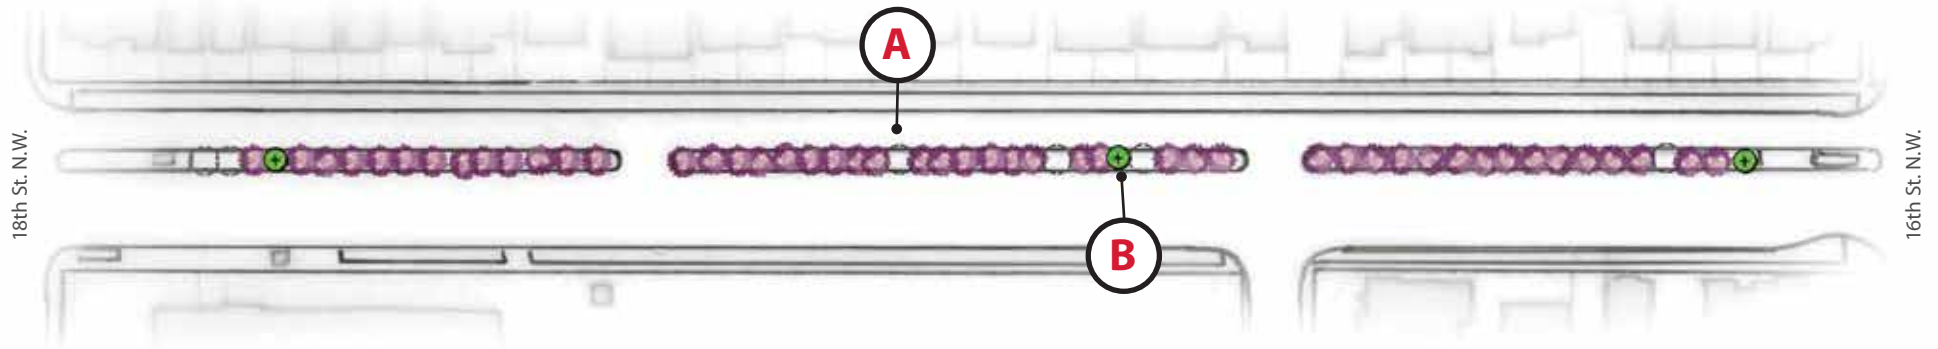
6th Ave. N.W. medians

- A 6 missing lilac on 6th Ave. N.W.
- C 9 missing lilac on Bowness Rd. N.W.

- B 3 newly planted tower poplar on 6th Ave. N.W.

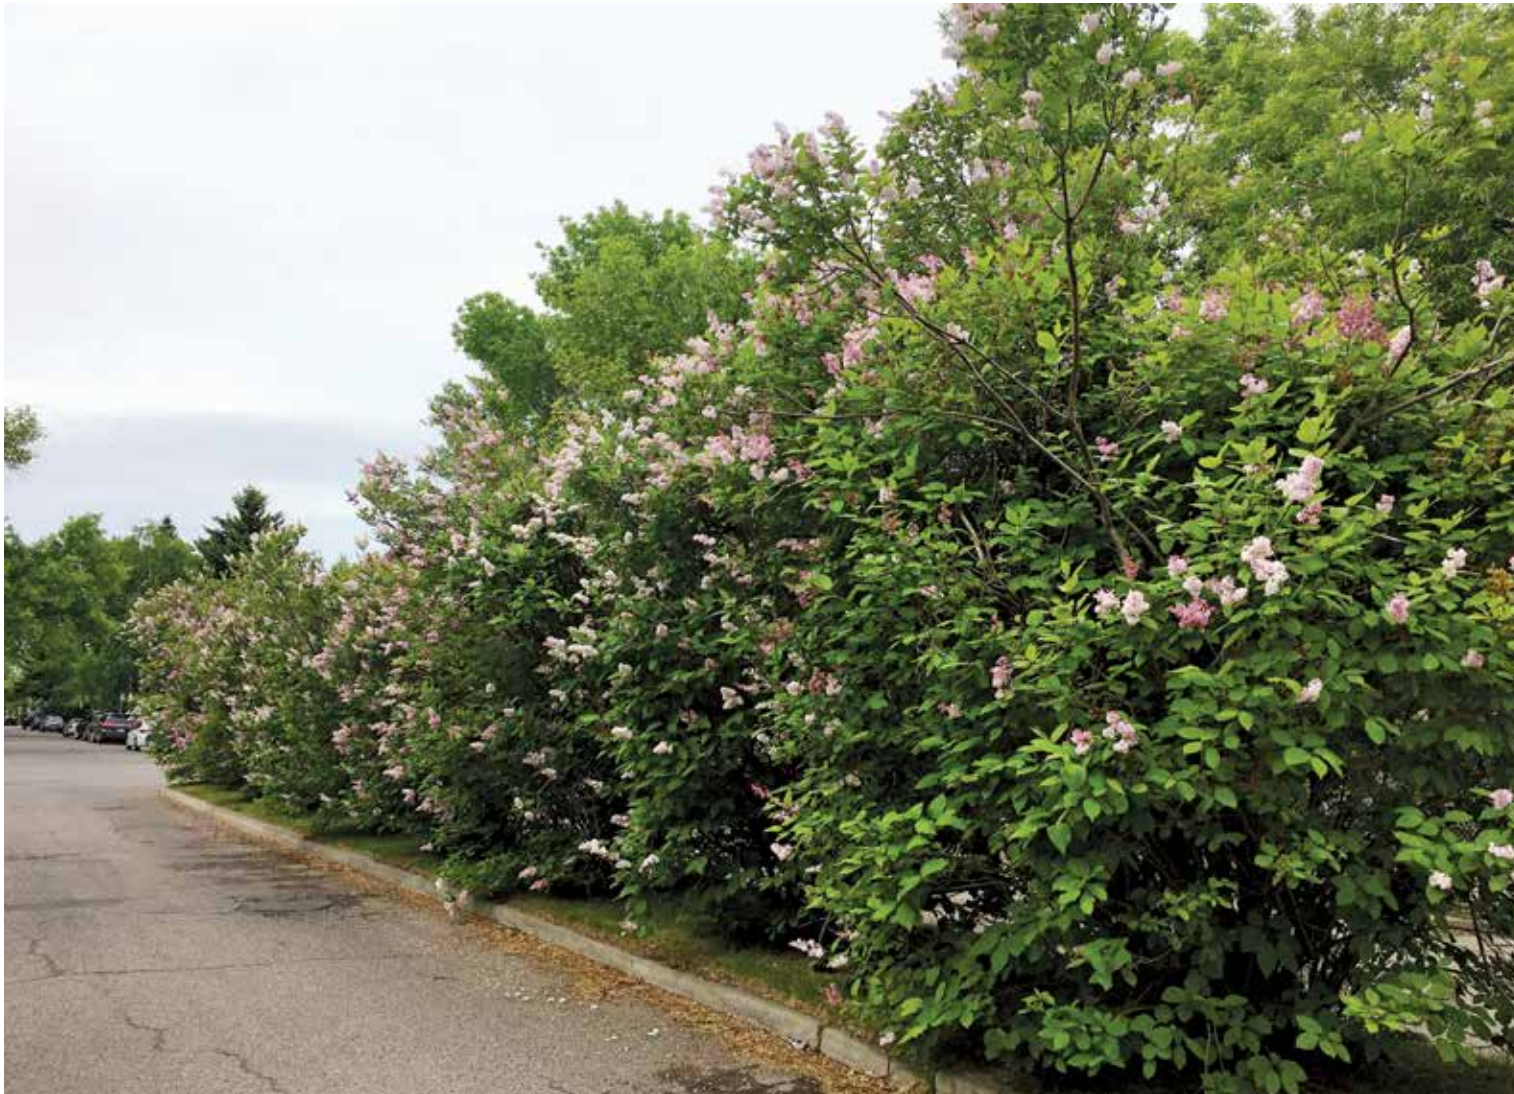
11th St. N.W. medians

All 9 lilacs in situ on 11th St. N.W.

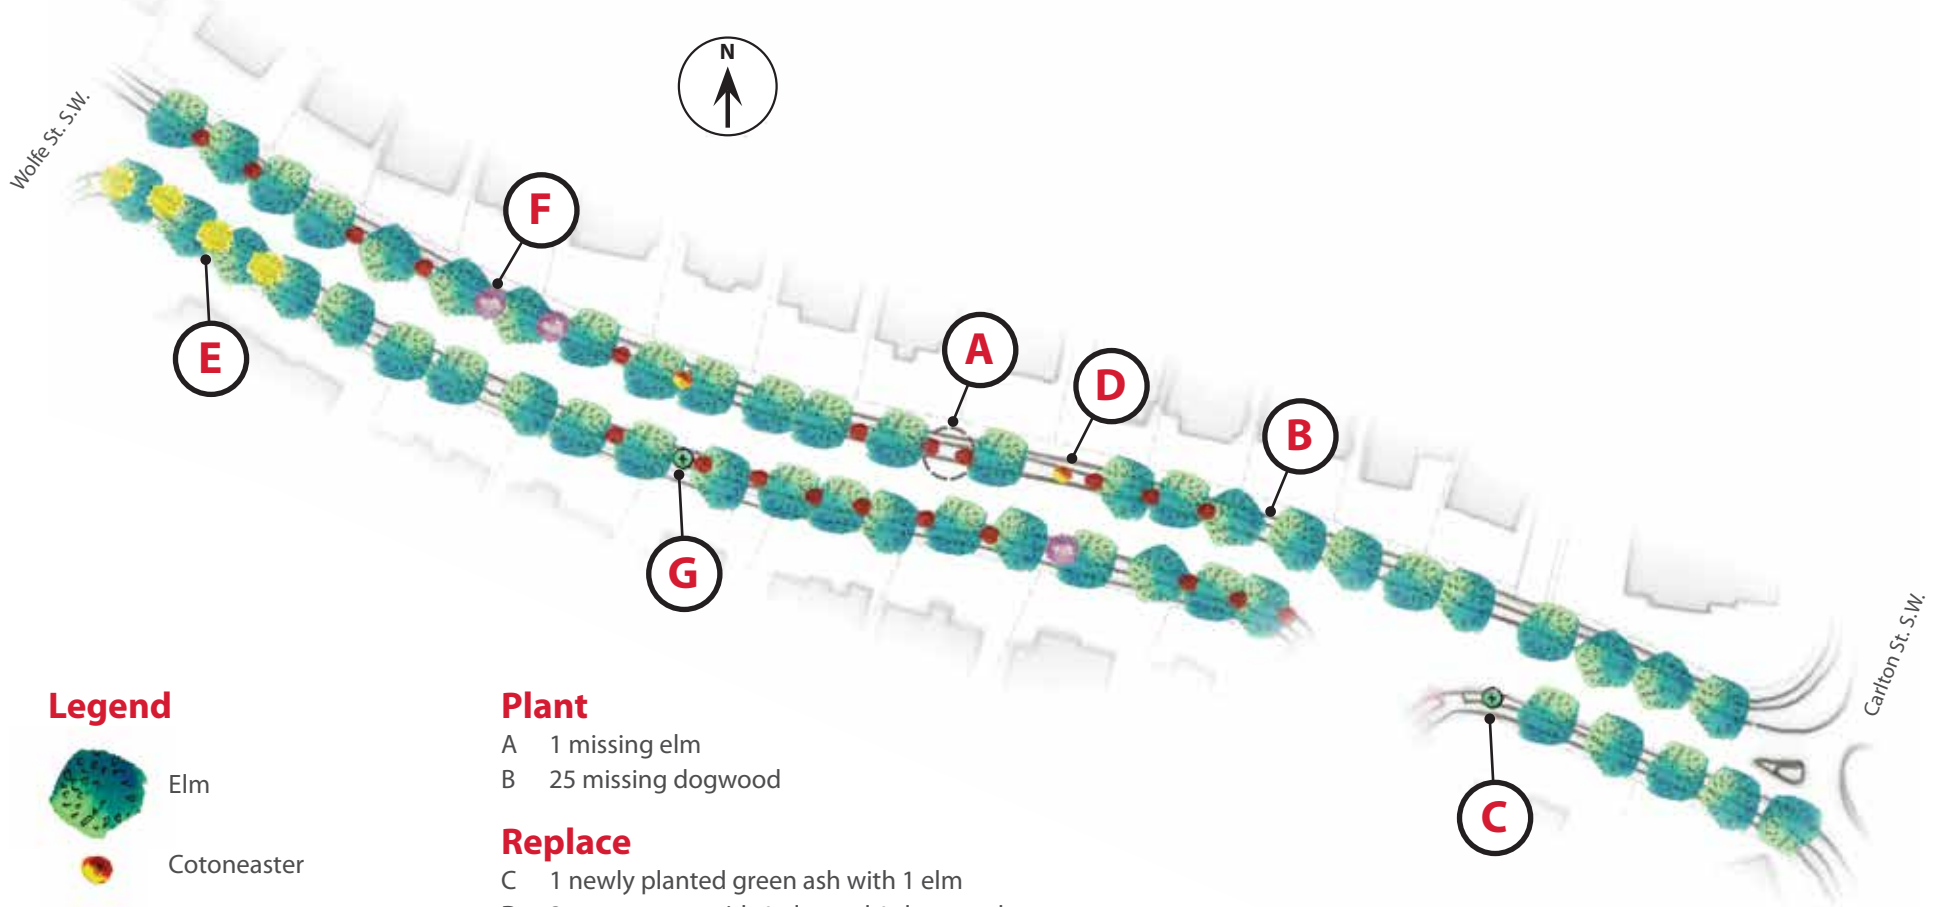
Frontenac Ave. S.W.

- A 1 missing elm
- B 25 missing dogwood

- G 1 newly planted elm

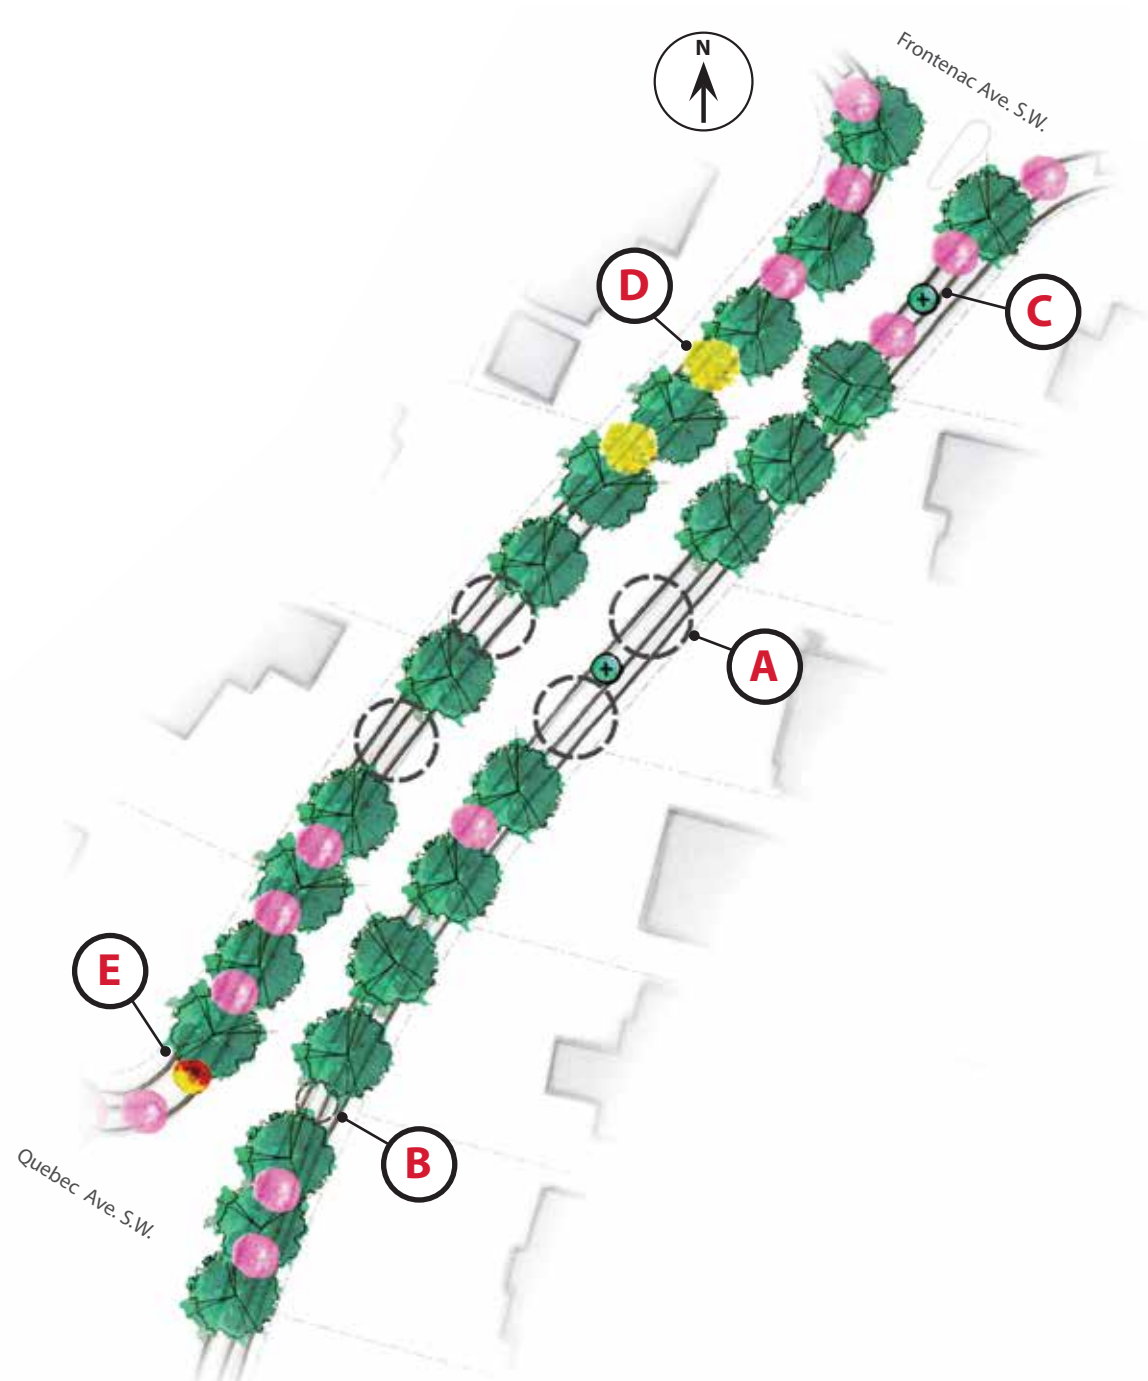
Montcalm Cres. S.W.

- A 4 missing green ash
- B 9 missing honeysuckle

- C 2 newly planted elms with 2 green ash
- D 2 caragana with 2 honeysuckle
- E 1 cotoneaster with 1 honeysuckle

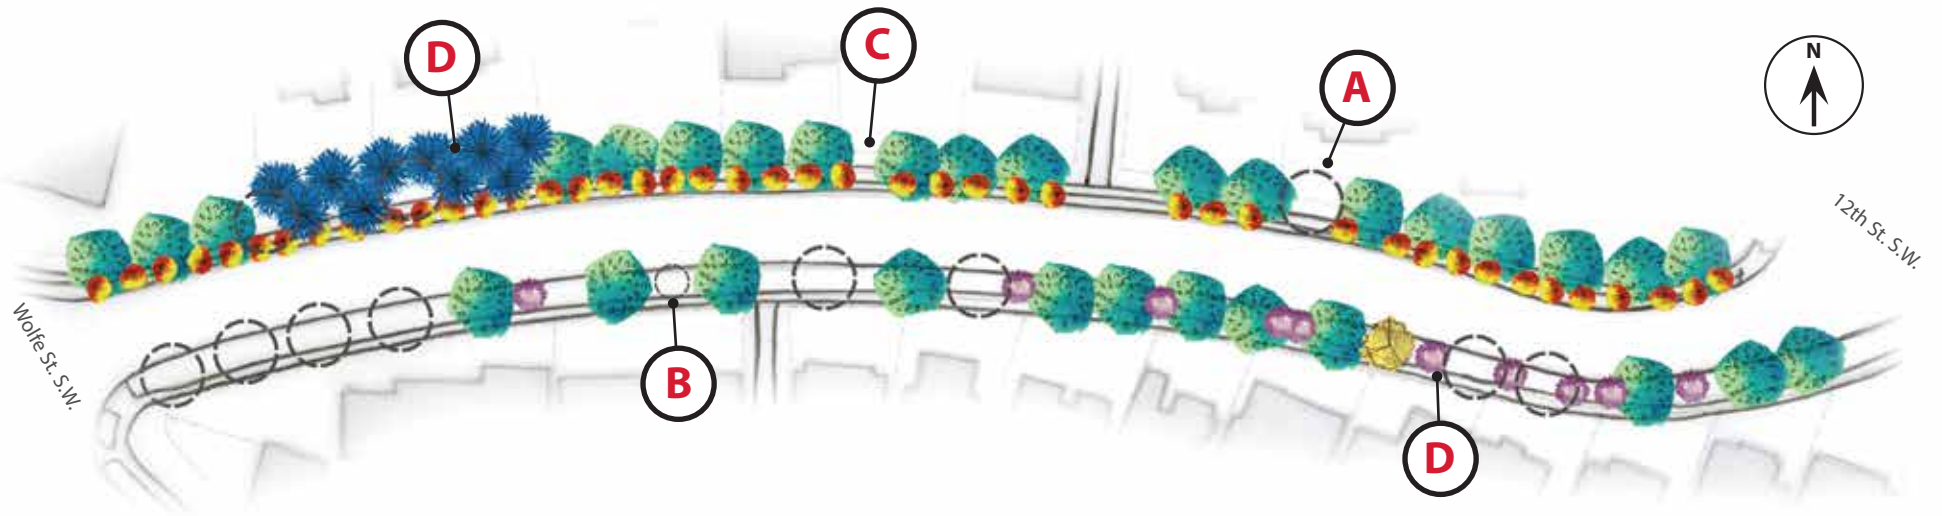
Montreal Ave. S.W.

- A 11 missing elms
- B 7 missing lilacs
- C 3 missing cotoneaster

- D 10 large spruce, 1 large mountain ash and replace when they are deemed too unsafe or too unhealthy by Urban Forestry

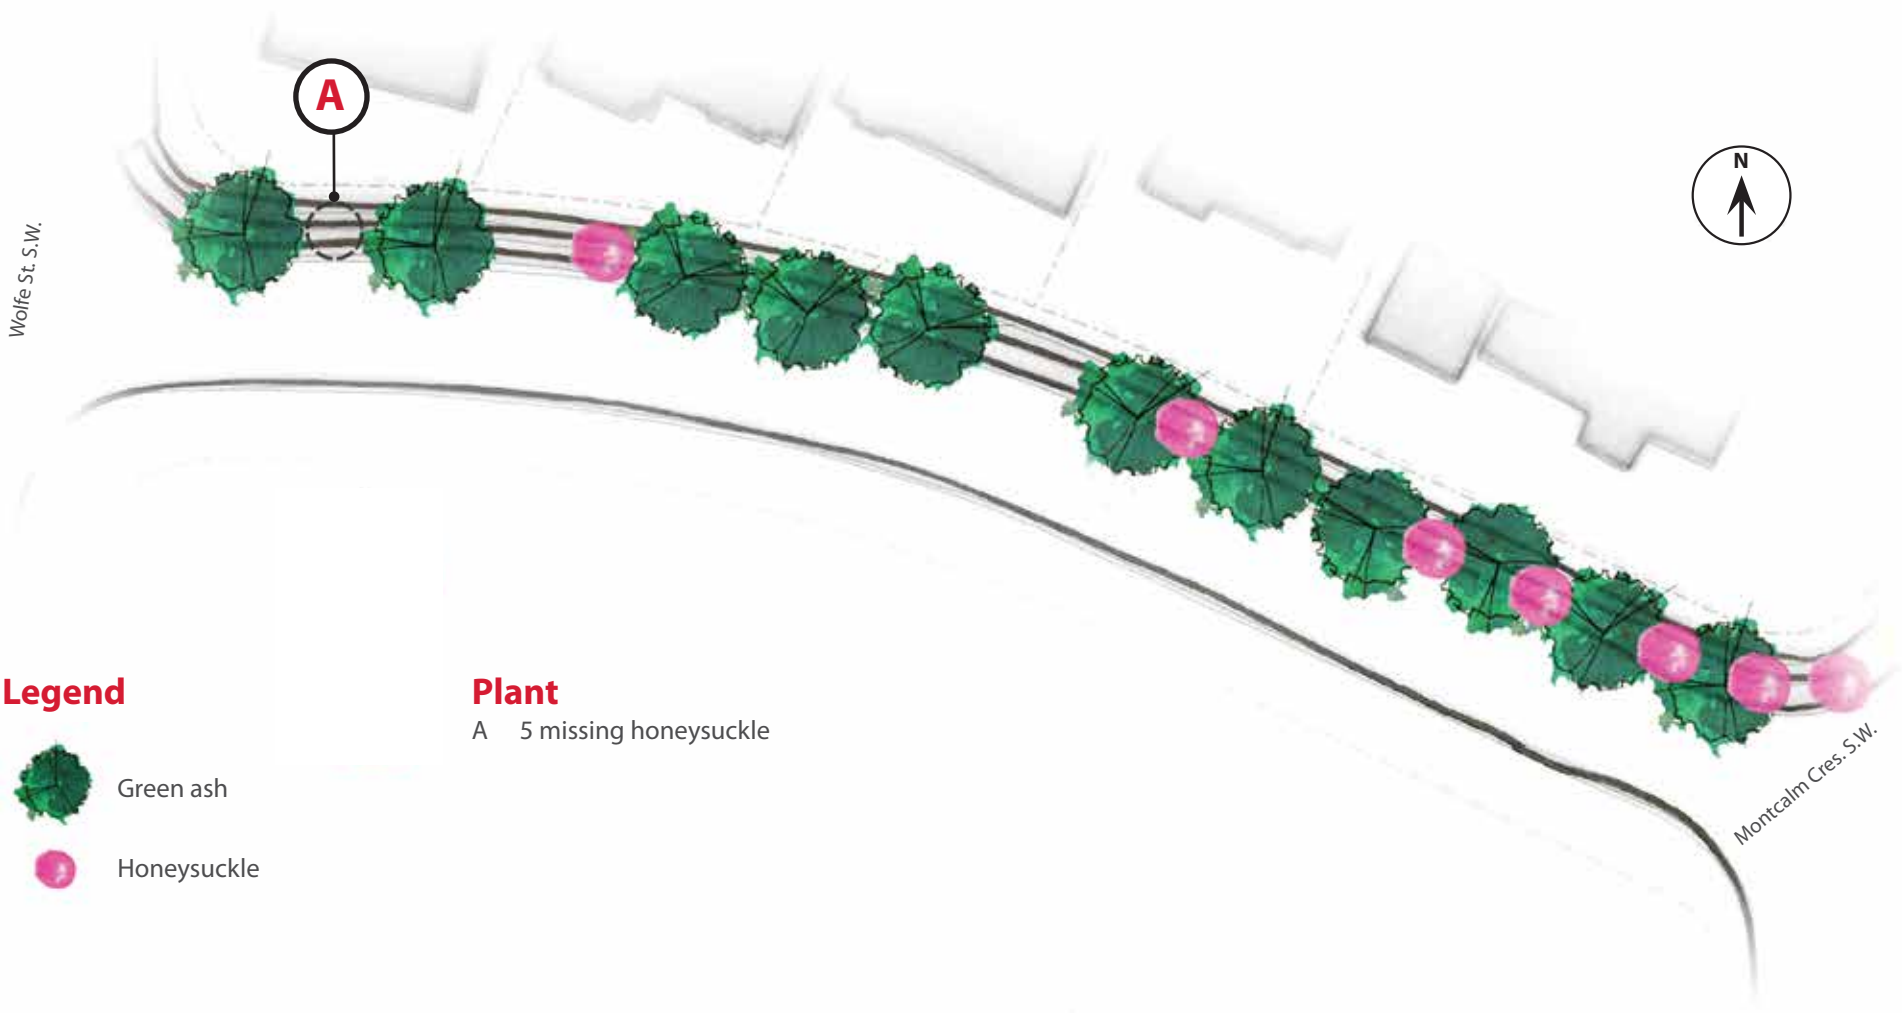
Quebec Ave. S.W.

A 5 missing honeysuckle

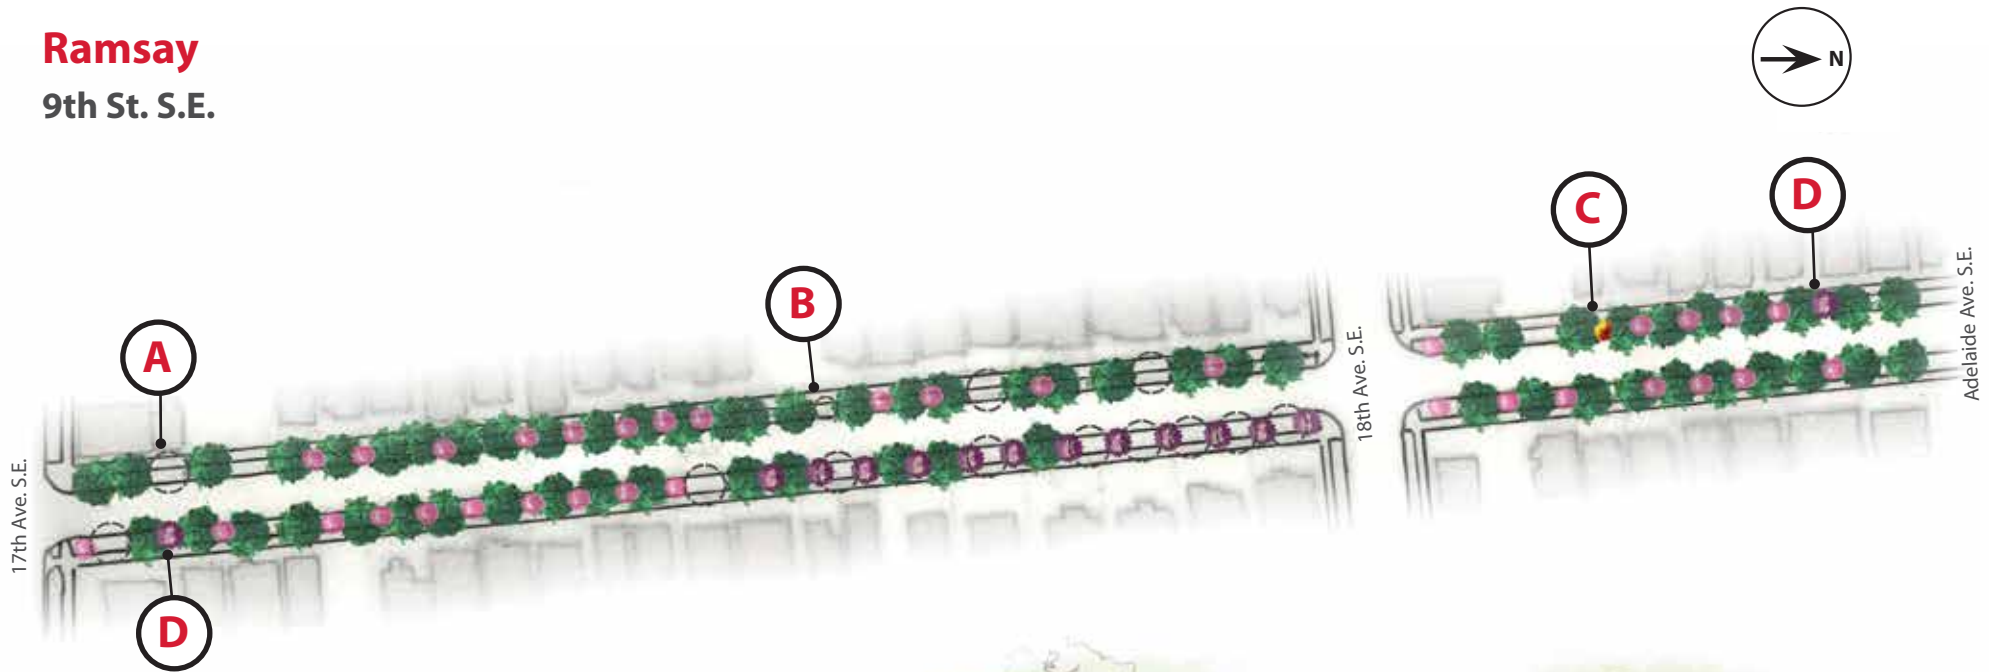
9th St. S.E.

- A 12 missing green ash
- B 26 missing honeysuckle

- C 1 cotoneaster with 1 honeysuckle
- D 2 lilac with 2 honeysuckle
