Conserving Calgary's Historic Streets

A conservation plan for 27 of Calgary's historic streetscapes

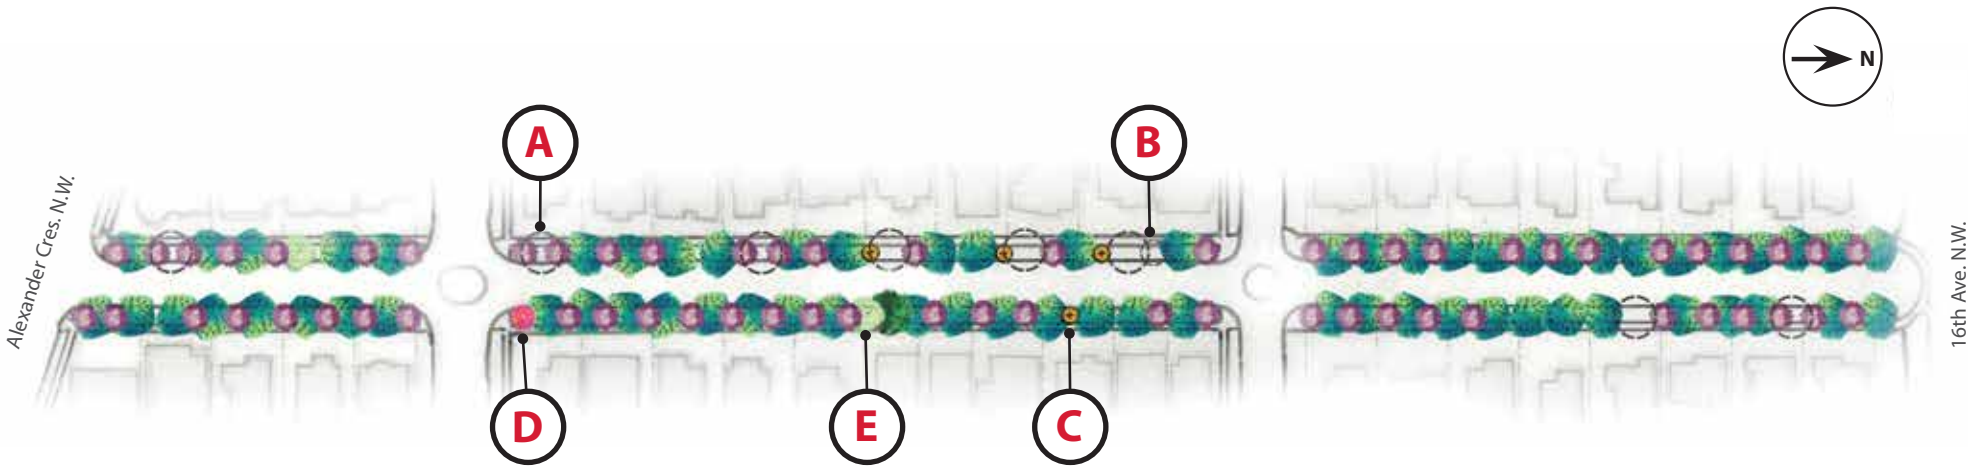
4A St. N.W.

- A 7 missing elms
- B 12 missing lilacs

- E 2 large maydays and 1 large green ash and replace when they are deemed too unsafe or too unhealthy by Urban Forestry

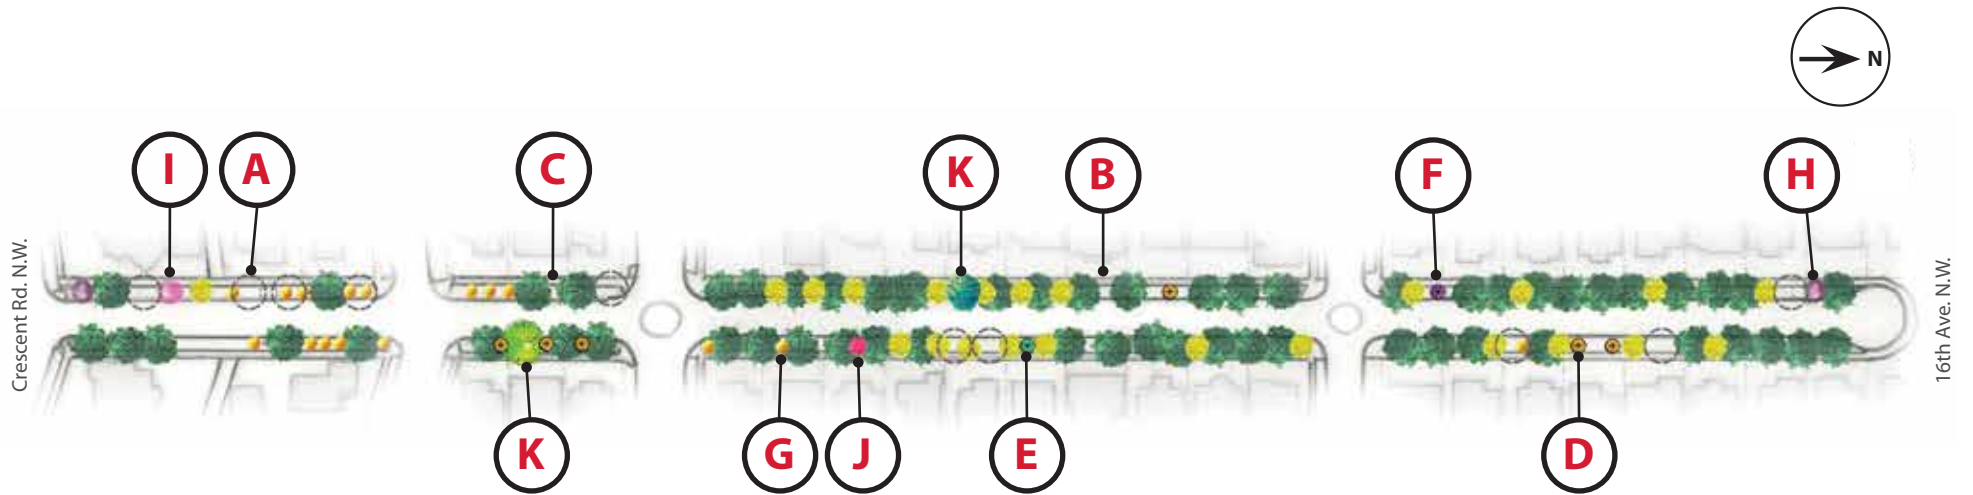
5th St. N.W.

- A 10 missing green ash
- B 30 missing caragana
- C 10 missing cotoneaster

- K 1 large elm and 1 large poplar and replace only when they are deemed too unsafe or too unhealthy by Urban Forestry

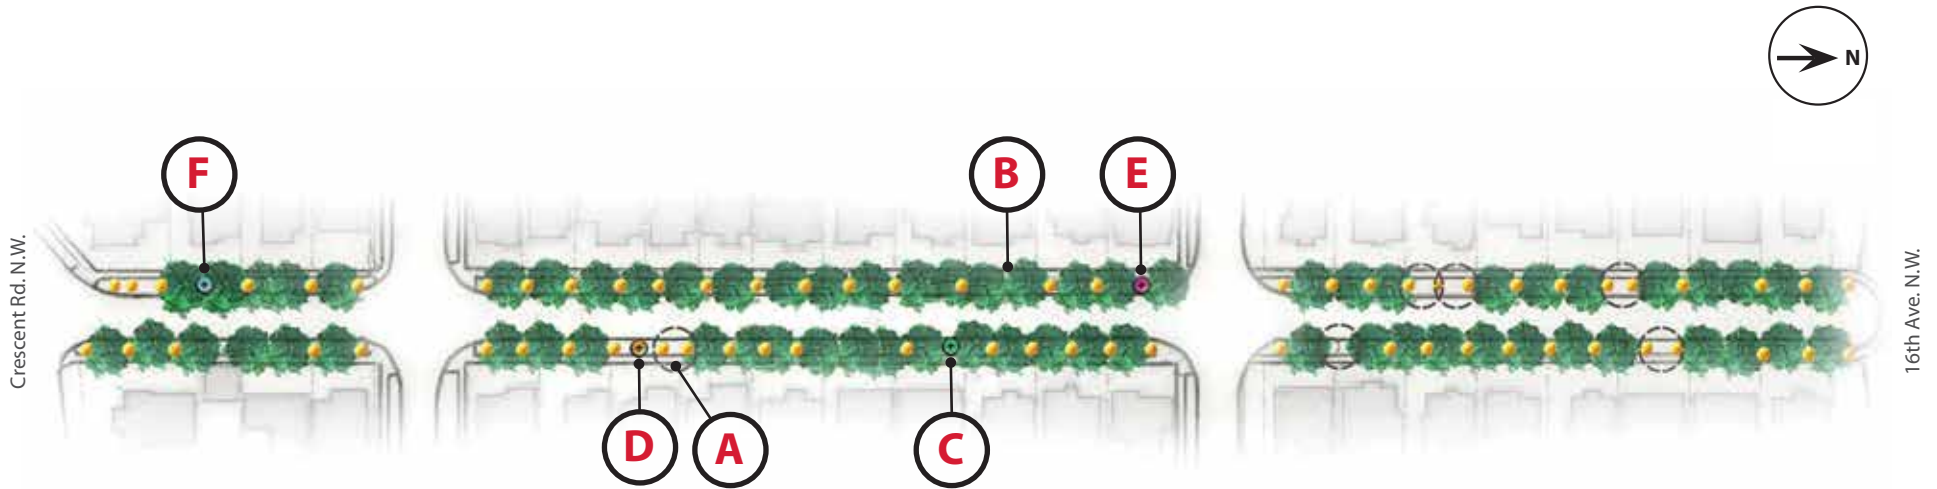
6A St. N.W.

- A 5 missing green ash
- B 8 missing cotoneaster

- C 1 newly planted elm with 1 cotoneaster
- D 1 newly planted oak with one green ash
- E 1 newly planted crabapple with 1 cotoneaster
- F 1 newly planted hawthorn with 1 green ash

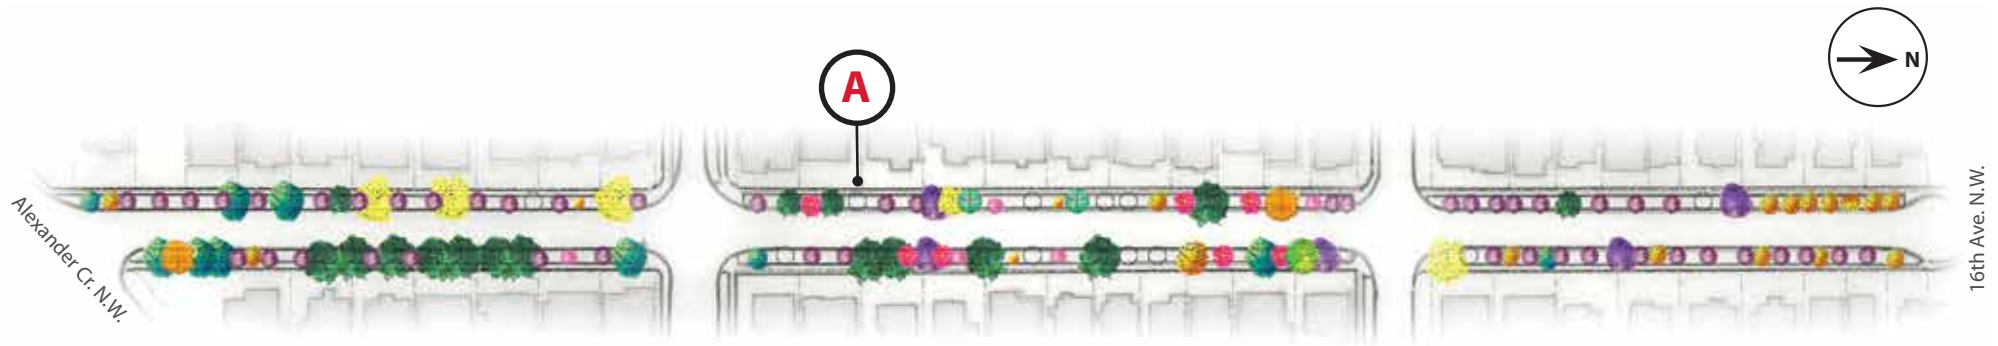
7th St. N.W.

A 11 missing lilacs

Actively retain only the lilacs. The spaces between the lilacs have been planted within the last 20 years with a variety of trees. There is no support to remove these trees to re-establish the historic lilac only pattern.

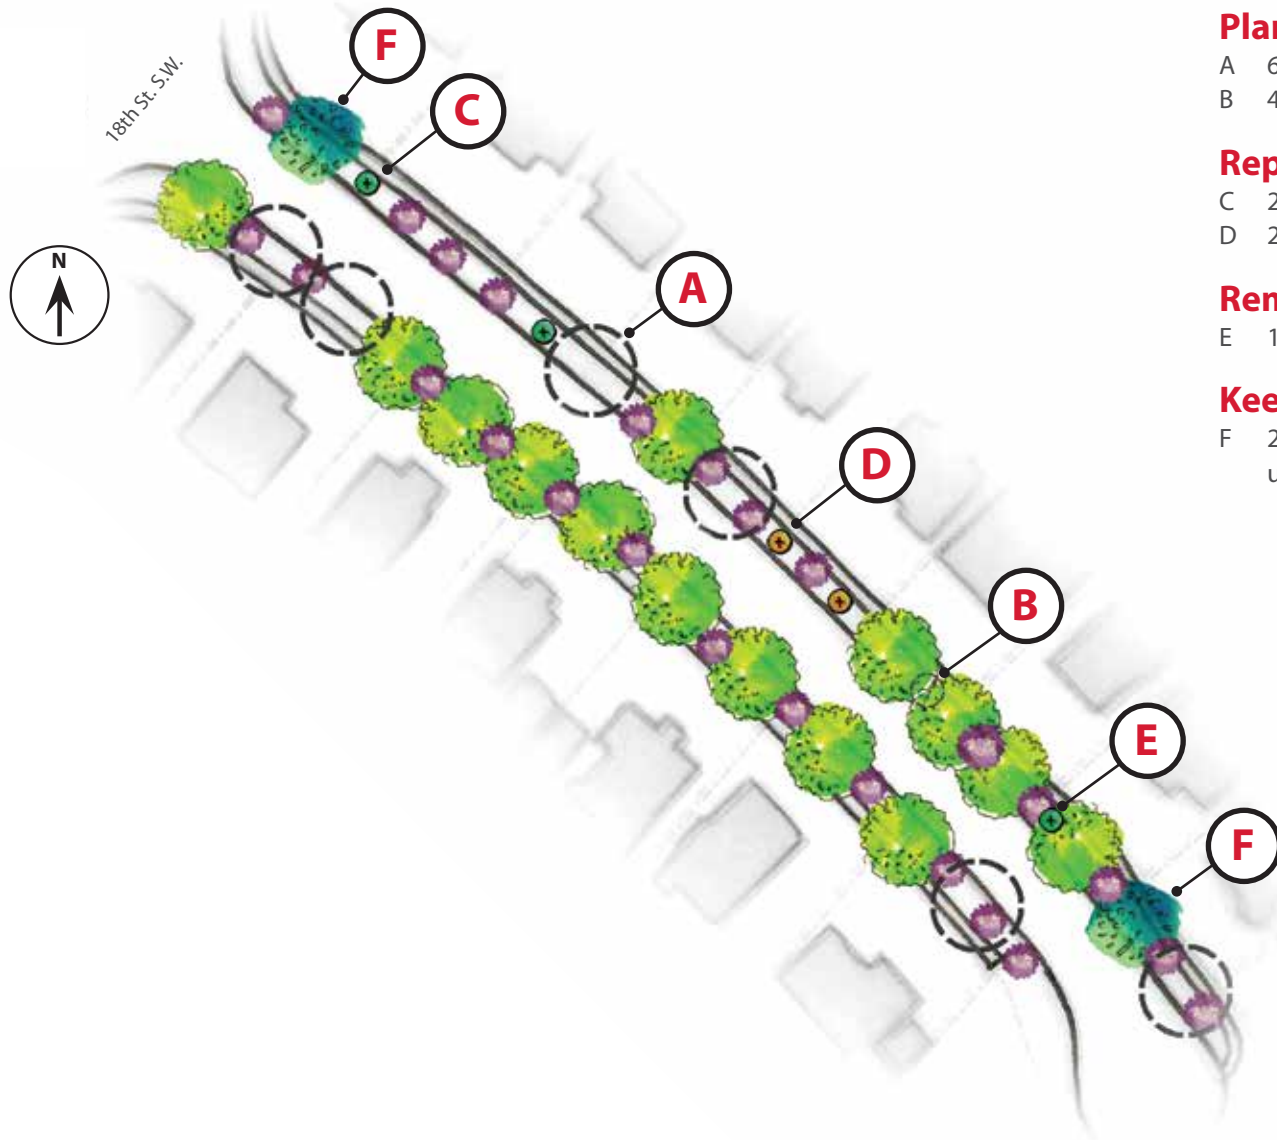
Sharon Ave. S.W.

- A 6 missing poplars
- B 4 missing lilacs

- F 2 large elms and replace when they are deemed too unsafe or too unhealthy by Urban Forestry
